SPECIAL REPORT ON SEA SURGE AT BOSHAM

10TH MARCH 2008

David West
 Bosham Parish Council Water Bailiff
 12th March 2008

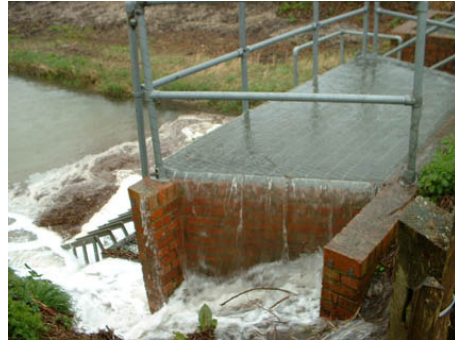
A2

Date/Time	Observations/Actions
1255	Sea water vents out of TOP of Stumps End grille chamber due to outer flap leaking seal. (Photo A2) Sea over-topping protective bank on Shore Road (Gosport side). Sea then flowing across field garden and down access track into Stumps Lane and therefore “bypassing” sea wall and hump. (Photo A3)
1300	Overtopping occurs opposite Stumps End grille and water flows around Shore Road hump and rushes to Stumps Lane. Tide level overtops Shore Road hump for about 10 mins. Attempt to ensure outer flap is fully down and closed. Turning mechanism underwater!! (Photo A4)
1310	<p>I return to Harbour Way and witness approx 1ft water in Meadow House garden and rising. I contact Fire Service to report imminent flooding of property. I visit the property and meet neighbour, no occupants so cancel Fire Service call. (They subsequently attend!). (Photo A5)</p> <p>PS tries to revisit Sailing Club position of 9th March. (Photo A6) This point is inaccessible, so measured sea level near the SW corner of the building from the top of the post on the wall supporting the flood barrier: guesstimated sea level 5.8m tide (3.3m OD). Water in Bosham Lane covered entrance to Bosham Walk, extending 10 -15 m further north. Very strong wind and pouring rain and hail. (Photo A7)</p>

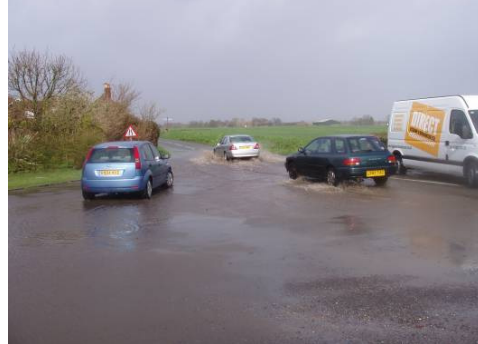
A8

1315	Stumps Lane now flooded and has extended to junction with Taylors Lane. (Photo A8) EH marked sea level at HT on “hump” on Shore Road/Stumps Lane for future level measurement (estimated level 3.3 OD)
1330	Whilst at Meadow House garden I am asked by Mr Pollock to advise on his generator organisation in the event of power cut.
1350	Meet with PN at Stumps Lane to obtain update. Stumps Lane flood now dispersed into holding area.
1400	Return home
