BOSHAM PARISH COUNCIL WATER BAILIFF

MONTHLY REPORT –SEPTEMBER 2008

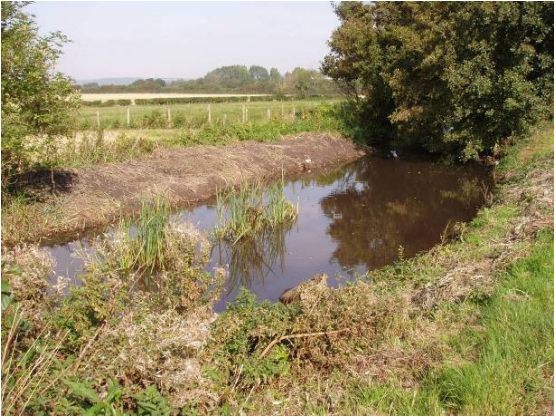
**For ever flowing manhole at entrance to Crede Lane
Bosham (off Walton Lane)
Continual flow for over 12 months.**

| Date | Site/Weather Situation | Observation | Action |
|---|--|--|--|
| Friday 19 th PP report | Churchfield Stream section Manhole cover at junction of Walton Lane and Crede Lane (see pic) | The problem with the Southern end is that the telegraph wires are on the N side of the ditch and as such the EA team cannot use the digger. He indicated that it will be cleared by hand. There is a constant torrent of water at the manhole opposite Crede Lane. | EA to clear manually? PP will write to Southern Water and hopefully they will investigate |

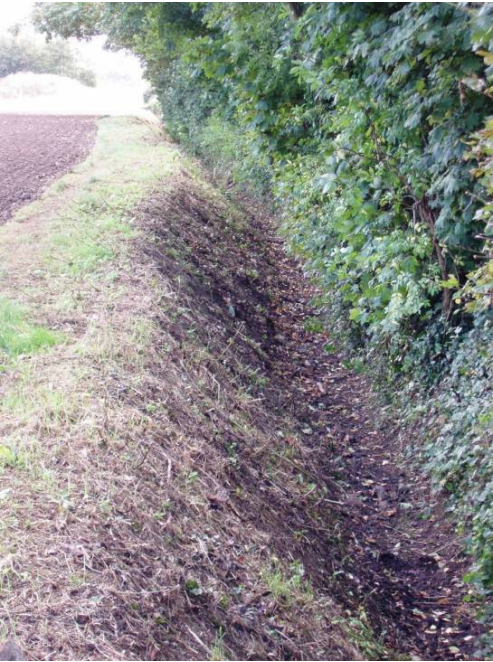
Ratham Lane section cleared

| Date | Site/Weather Situation | Observation | Action |
|---|--|--|--|
| Monday 22 nd | Ratham Lane and East Ditch (from <i>Frenchams</i> downstream) | EA have now cleared these sections BUT the fallen tree still obstructs the flow. | See pictures in Appendix. |
